INDOOR AIR QUALITY ASSESSMENT

**Berkshire Athenaeum
1 Wendell Avenue
Pittsfield, Massachusetts**

Prepared by:
Massachusetts Department of Public Health
Bureau of Environmental Health Assessment
November 2002

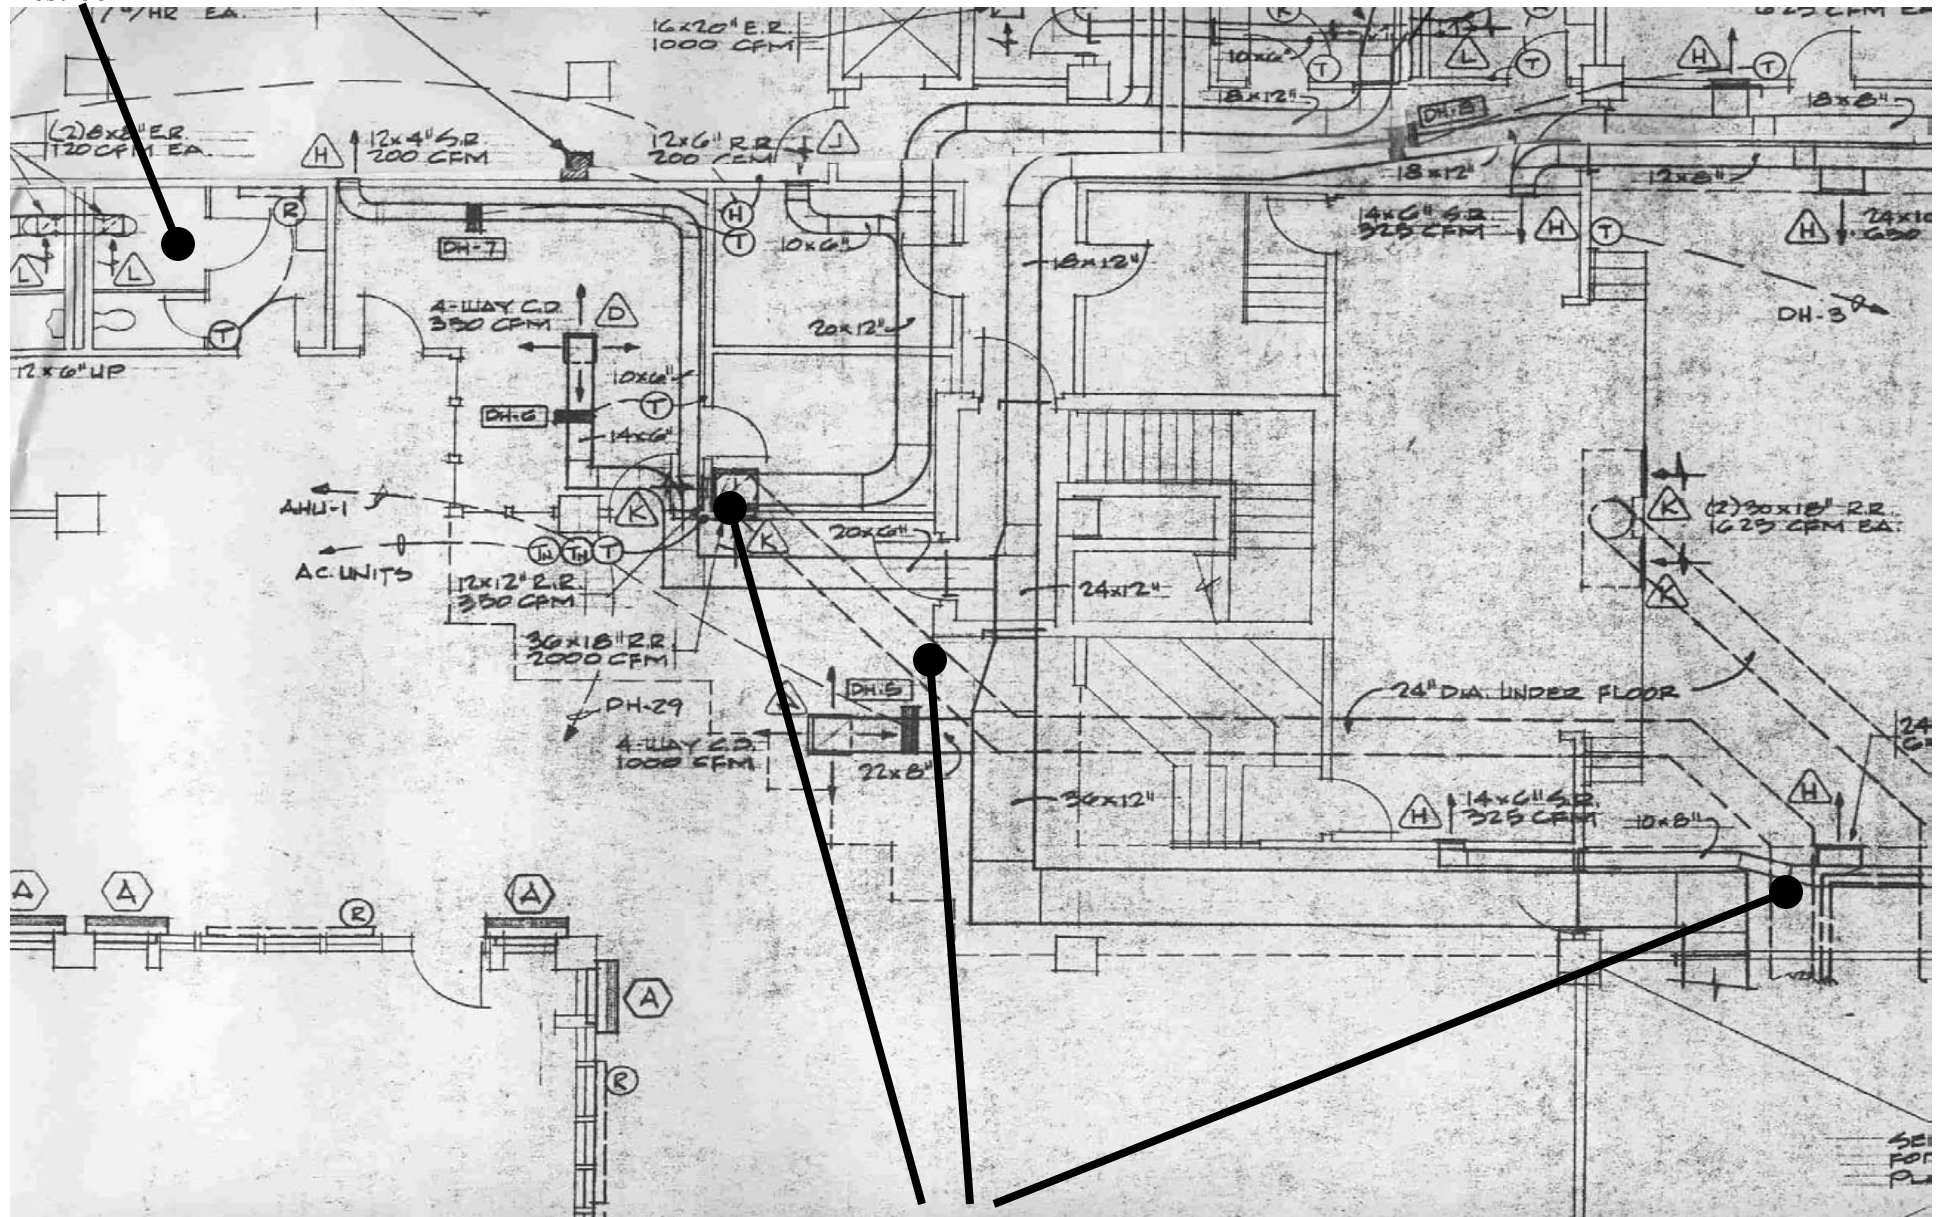
Map 1

(e.g., every other day), traps can dry, which breaks the watertight seal. Without traps wet, odors can travel up the drain and enter the occupied space. Under ordinary circumstances, the restroom exhaust vent will draw air from the drain to the wall-mounted grille to the roof motor. The restroom exhaust vents were deactivated, therefore no removal of malodorous air was evident in the restroom.

The return air vent for the lower floor in the children's library is located near a stairwell. Without operating restroom exhaust vents, the lower floor return vent can draw odors from the restrooms through the doorframe, towards the children's library front desk. The areas examined above correspond to areas of strongest odor complaints diagramed on a floor plan provided by Mr. Latham.

Slab Installed Exhaust Vent Duct in Lower Floor, Note Restroom Location vis-à-vis exhaust vent

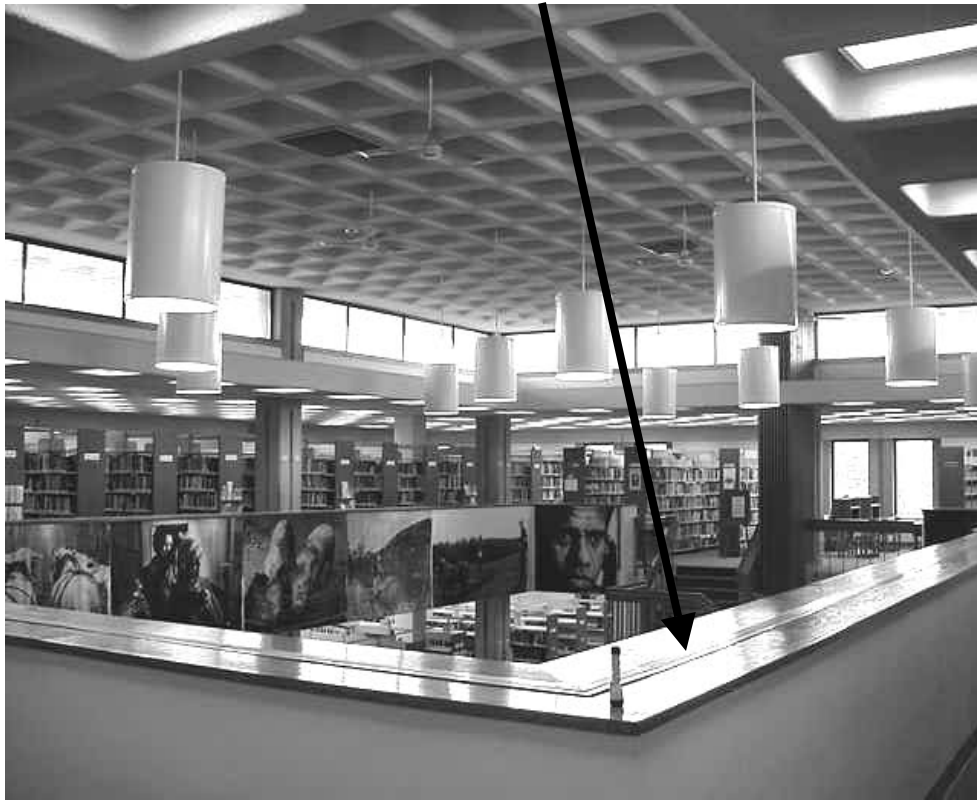
Picture 1

The atrium also has a cabinet mounted blower that heats and chills air as needed (see Picture 1). It was unclear whether this system provides fresh air. The system was operating during the assessment.

Air Diffuser In Cabinet

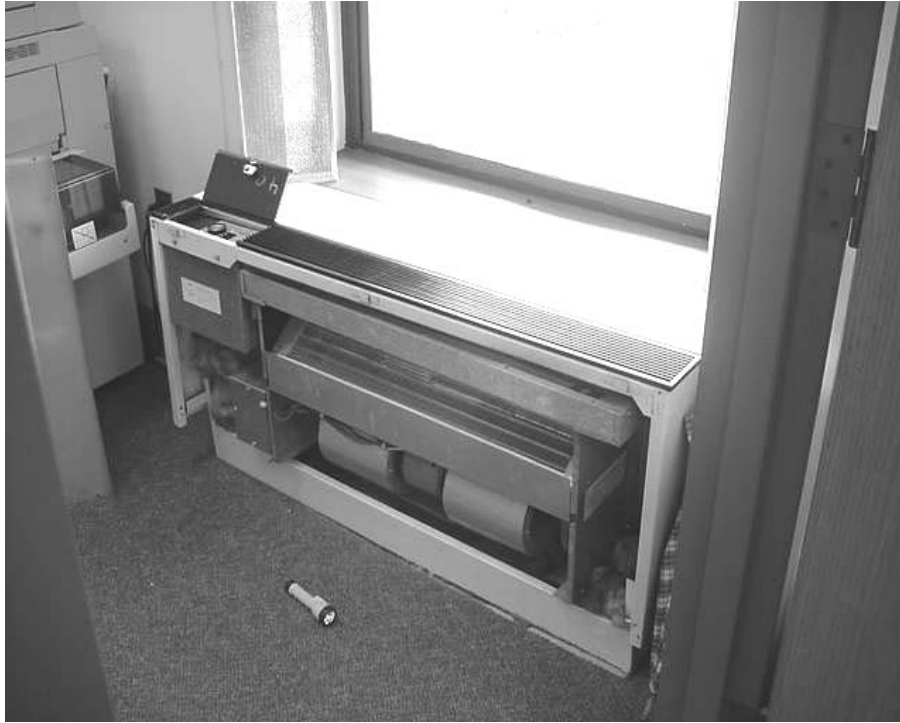
Picture 2

The ventilation system is divided into two sections: the upper floors and the lower floor. The upper floors of the BA are supplied with fresh air by a combination of air handling units (AHUs) and unit ventilators (univents) (see Picture 2). The majority of fresh air is distributed to offices and other enclosed rooms by ceiling mounted fresh air diffusers connected to each AHU via ductwork. In several areas no air movement was detected from air diffusers, indicating AHUs were deactivated. Univents are located along exterior walls. Fresh air appears to be drawn by each univent through a small louver located in the rear of its cabinet (see Picture 3). Each louver is set by hand to either a closed or open position (see Picture 4). Due to the size of the opening and installation, it appears that draw of fresh air by these univents is minimal. In the closed position each univent performs as a fan coil unit (FCU), which functions to solely heat or chill air without introducing outdoor air. A number of univents/FCUs were deactivated throughout the building.

Univent

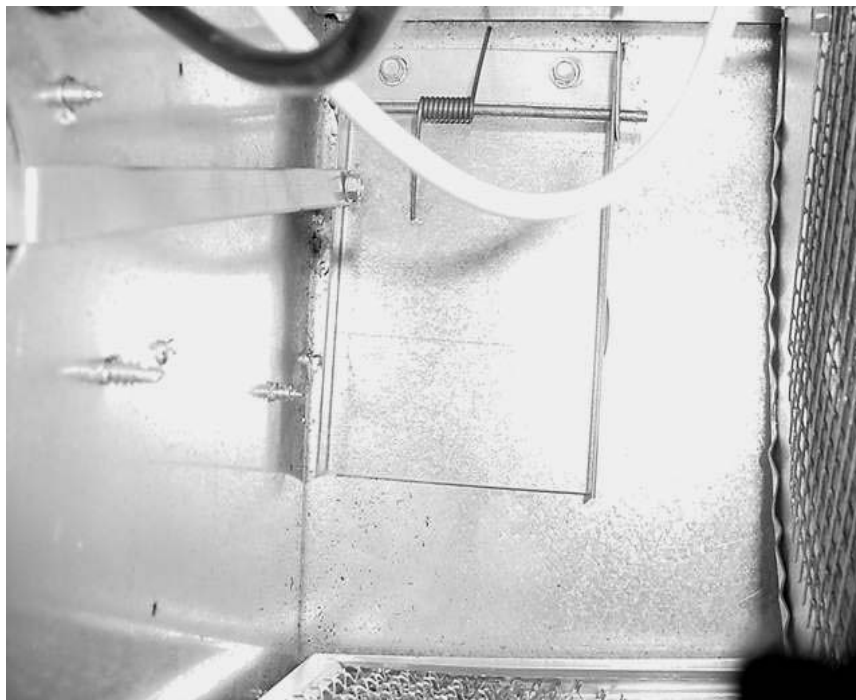
Picture 3

Small Handset Louver in Rear Of Univent

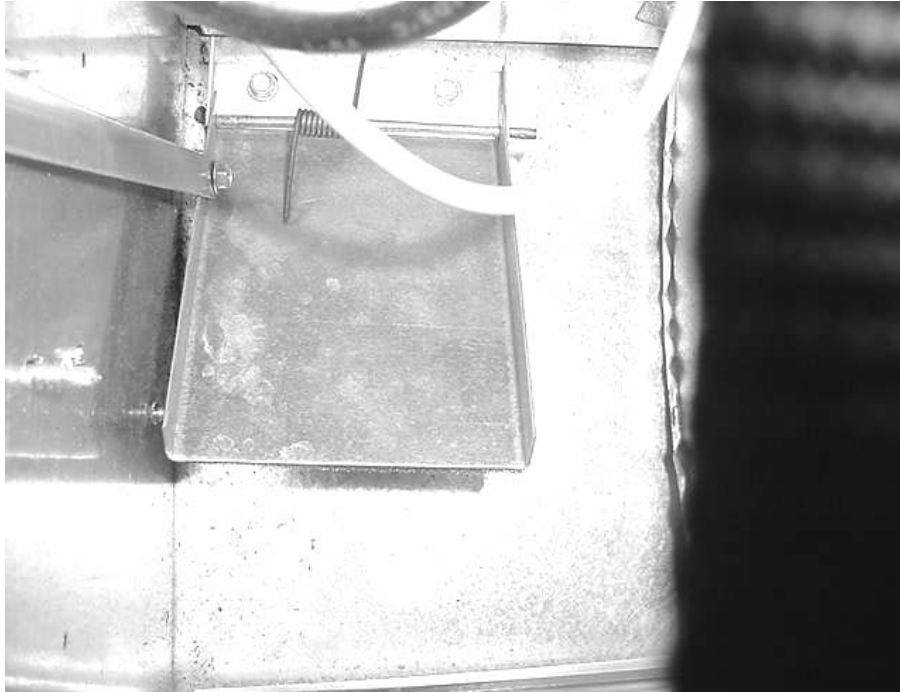
Picture 4

Univent Louver Set in The Open Position

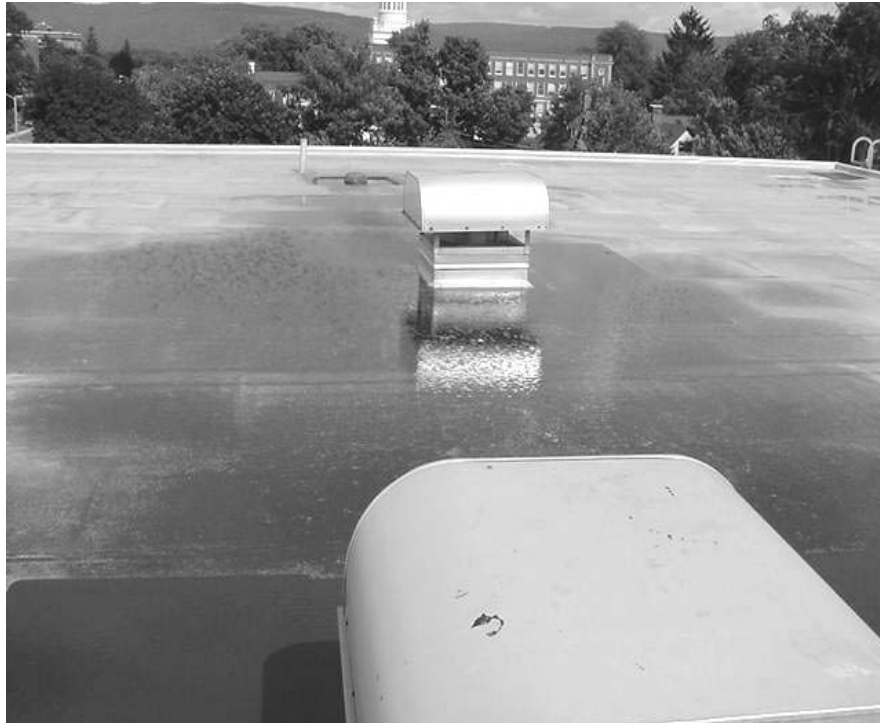
Picture 5

Exhaust ventilation is provided by a number of rooftop units (see Picture 5). Exhaust air appears to exit the atrium from ceiling mounted grills (see Picture 6). An

examination of the roof found fifteen of eighteen exhaust fans deactivated. Without exhaust ventilation, normally occurring environmental pollutants (e.g., waste heat from electronic equipment such as computers, microfilm viewers, fluorescent lights, etc.) can build up and lead to indoor air quality and comfort complaints.

Roof Top Exhaust Fans, Note Standing Water

2. Repair the fan motor for the lower floor AHU and operate to pressurize the AHU cabinet to prevent odor entrainment via the condensation drain.
3. Repair/activate exhaust vents on roof. Operate exhaust ventilation during working hours.

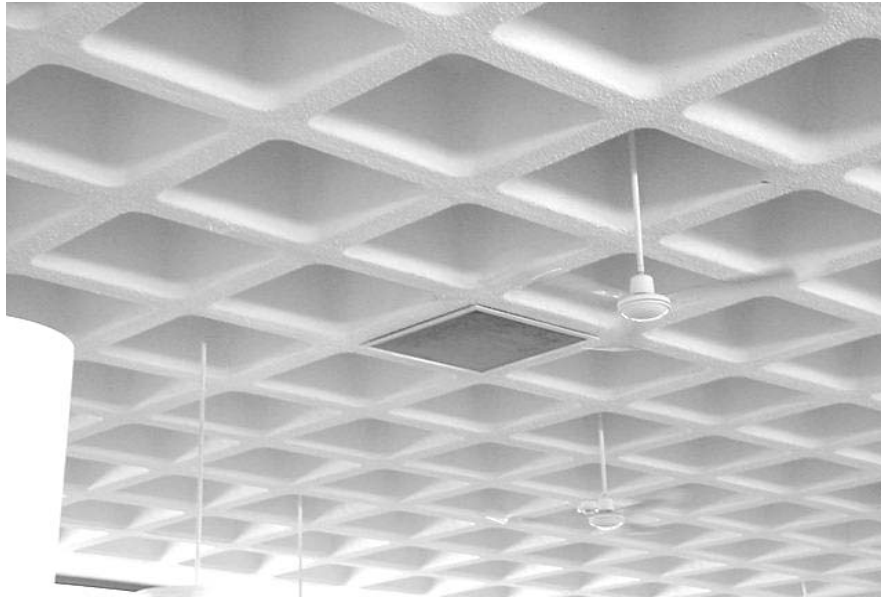
Picture 6

Exhaust Vents on Ceiling Of Atrium

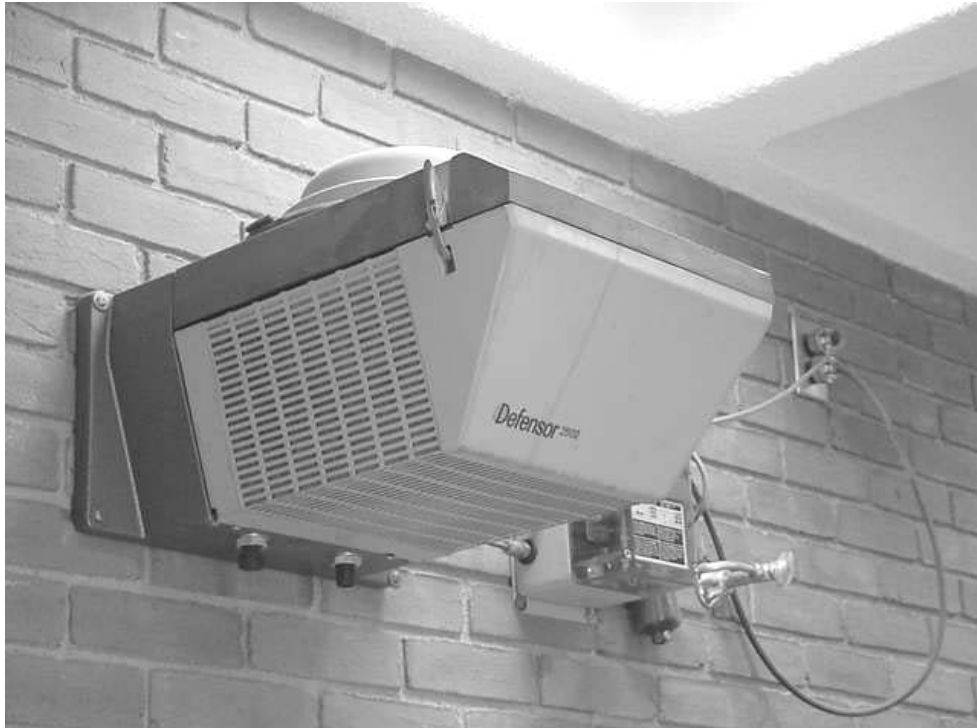
Picture 7

Wall-mounted humidification units were installed throughout the BA during its construction (see Picture 7). A humidification system was also installed within the supply ductwork of the lower floor AHU. Mr. Latham reported that the wall-mounted humidifiers are not used due to excessive noise generation. One unit was activated, which produced a loud motor noise. Humidification equipment, if not maintained, can be a source of moisture and/or microbial growth. The interior of the ductwork connected to the humidification system could not be examined during the assessment. If repairs are not made to the humidification system to restore its function, it is advised to permanently decommission and possibly remove the system from the ventilation ductwork.

Wall-Mounted Humidification Units

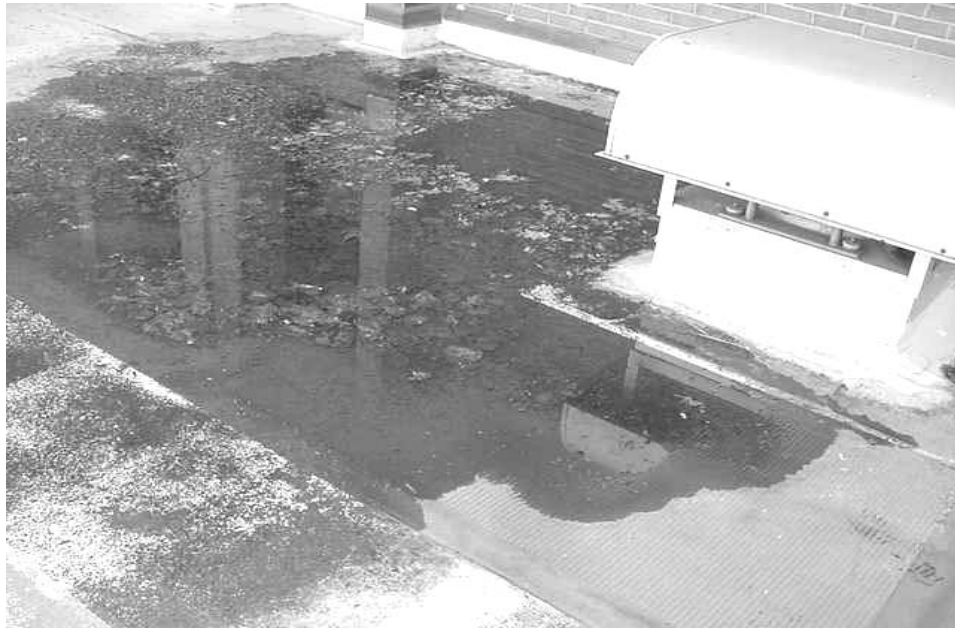
Picture 8

Various forms of debris [leaves (see Picture 8), old fiberglass insulation (see Picture 9), etc.] were noted in direct contact with the rubber membrane roof. In one instance, plants had taken root in the debris and were growing on the roof membrane (see Picture 10). Debris can hold water in contact with the roof, which may cause damage resulting in leaks from freezing and thawing during cold weather.

Debris on Roof, Note Pooling Water

5. Clean accumulated debris from floor of subterranean fresh air intake pit and roof periodically.
6. Operate restroom local exhaust ventilation during work hours. Repair motors as needed.

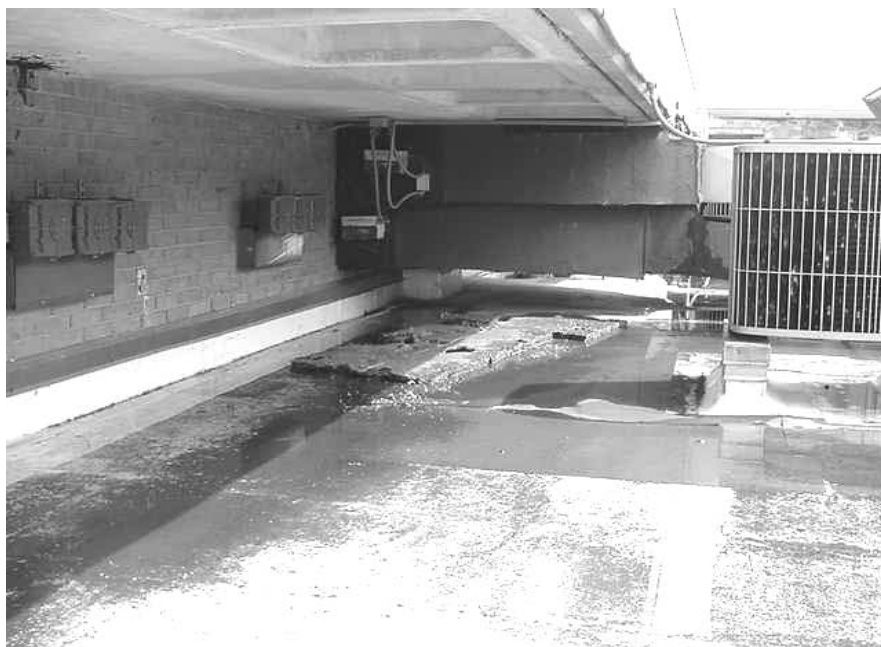
Picture 9

Fiberglass Insulation on Roof

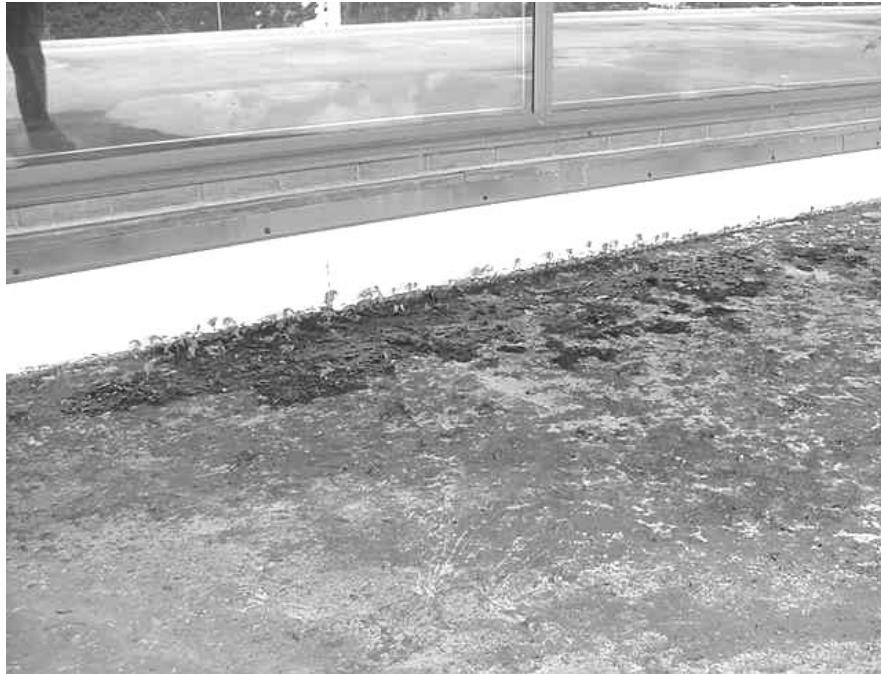
Picture 10

Plants Had Taken Root in The Debris and Were Growing on The Roof Membrane

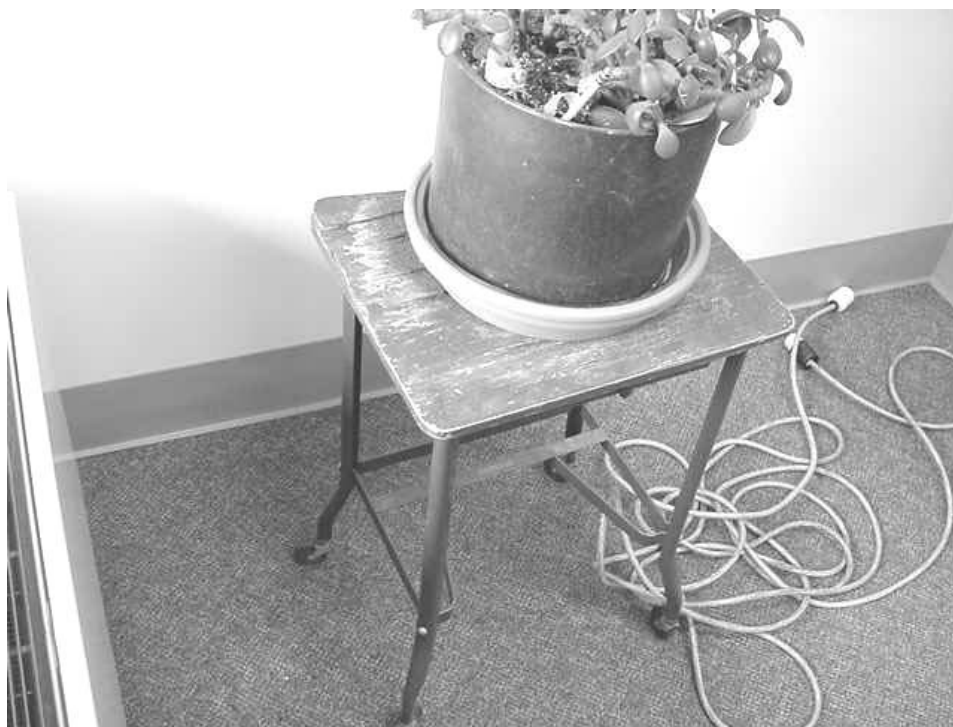
Several areas had a number of plants. Plant soil and drip pans can serve as source of mold growth. A number of these plants did not have drip pans. The plant in Picture 11 appears to be chronically over-watered. The desk that this plant rests on is water damaged. The lack of drip pans and/or over-watering can lead to water pooling and mold growth on porous materials (e.g. carpeting and wood). Plants should be properly

Over watered Plant in Catalogue Area

11. Move excessive numbers of plants from windows. Ensure plants have drip pans. Examine drip pans periodically for mold growth and disinfect with an appropriate antimicrobial where necessary.

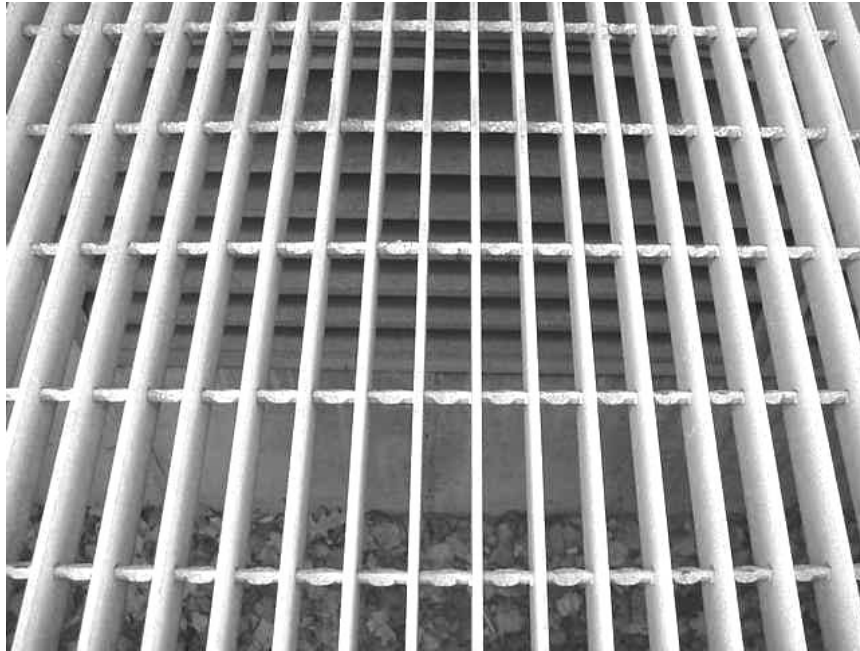
Picture 12

As discussed, the fresh air intake for the lower floor is located in a subterranean pit below the north wall (see Picture 12). Subterranean pits tend to be prone to collection of moisture from rainwater and debris. If materials lining the floor of the pits are saturated with water, mold spores, water vapor and associated odors can be entrained into the AHU.

Subterranean Pit That Serves as Fresh Air Intake, Note Leaves on Floor

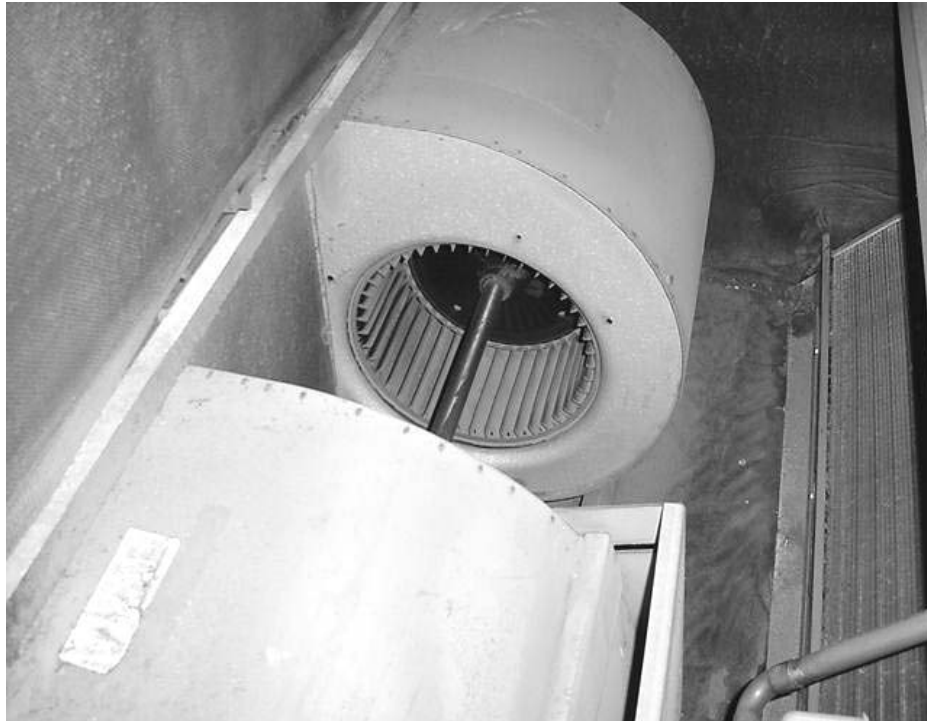
Picture 13

2. Another possible source of odor is the condensation drain that services the AHU providing fresh air to the children's library. The ventilation system for the lower floor is designed with a second fan (the second fan) to distribute air from and a fan within the AHU that draws fresh air and distributes it to the lower floor through a wall-mounted fresh air diffuser. In order to operate as designed, both fans must operate simultaneously. The fan in the AHU was deactivated (see Picture 13). The airflow through this ductwork appears to be provided by a unit separate from this AHU. This AHU is equipped to provide air-conditioning during warm months. AHUs that provide air-conditioning require the installation of condensation drains to prevent water build up inside the casing and ductwork. The condensation drains for these units terminate above a floor drain that is connected to the building drainage system (see Picture 14). Without the AHU fan running, the operation of the second fan depressurizes the AHU cabinet, which results in air being drawn to the cabinet via the condensation drain. If the

Deactivated AHU Fan in the Lower Floor AHU

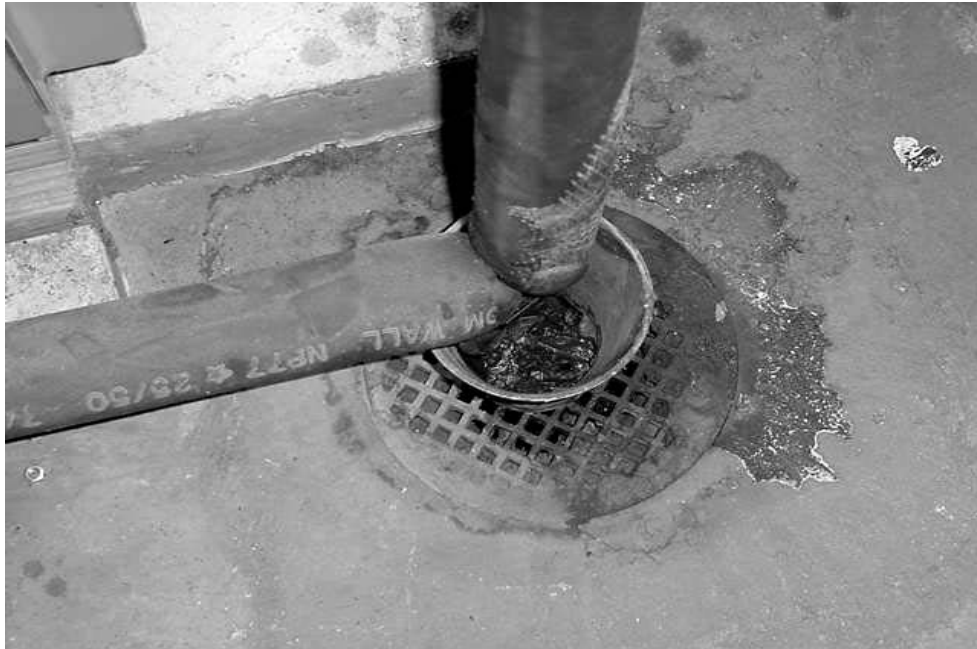
Picture 14

trap for this condensation drain is dry, the operation of the separate unit can then draw air and odors from the drain system and distribute them into occupied spaces on the lower floor. If the AHU fan is reactivated, the section of the cabinet where the condensation drain exists will become pressurized. Once pressurized, air is forced out of the condensation drainpipe preventing the entrainment of odors from the drain system by the ventilation system.

Condensation Drain for Lower Floor AHU, Note Accumulated Debris in Cup
